# A Business Case for PA-4

## *Drill break detection*

High precision bar-turning and milling with natural diamond turning tools

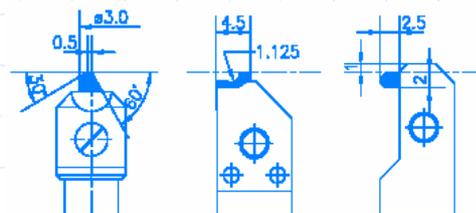
**Part and diamond cutting tools.**

These very small and delicate parts are machined with extremely small tools, and require several machining steps, the first of which is drilling a hole, which then subsequently is tapped, threaded, and /or deburred with natural diamond cutting tools. The expensive parts, which require extreme precision and accuracy are manufactured on 12 advanced technology CNC automatic lathes. Rickli prides itself on their commitment towards continuous improvement of their production techniques in order to meet and exceed customer requirements

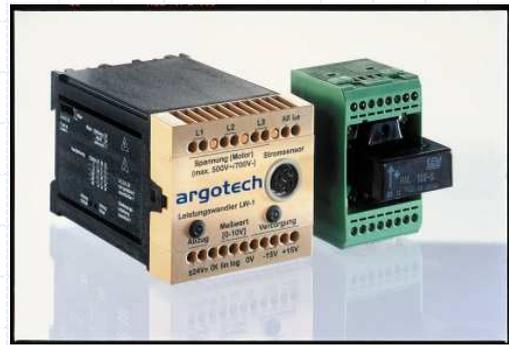
**LW-1 Power consumption sensor**

To solve Rickli's problem, a PA-4 was installed with a LW-1 power consumption sensor. At highest sensitivity, it was possible to distinguish between the power demand of the machine when drilling actually was taking place and the power consumption when drilling was not taking place and thus the drill had broken.

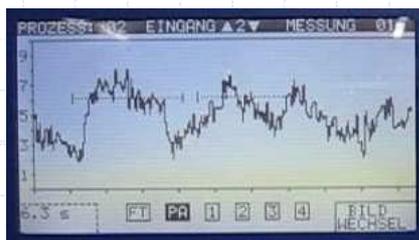
**PA-4 screen with limit values**

Limit values were set at the places in the production cycle when drilling took place, which had to be breached by the sensor signal. If they were not breached, it meant that the power consumption was too low and that drilling had not taken place. If such a condition occurred the machine would be shut down.
